**CONSERVATION  
- RESTORATION  
WORKS ON WALL  
PAINTINGS IN THE  
HVAR THEATRE**

## **PROJECT OF RESTORATION OF THE HVAR ARSENAL AND THEATRE FOR THE TOWN OF HVAR**

## THE FIRST PHASE OF CONSERVATION AND RESTORATION WORKS ON WALL AND CEILING PAINTINGS IN THE THEATRE

## **THE SECOND PHASE OF CONSERVATION AND RESTORATION WORKS ON WALL PAINTINGS IN THE THEATRE**

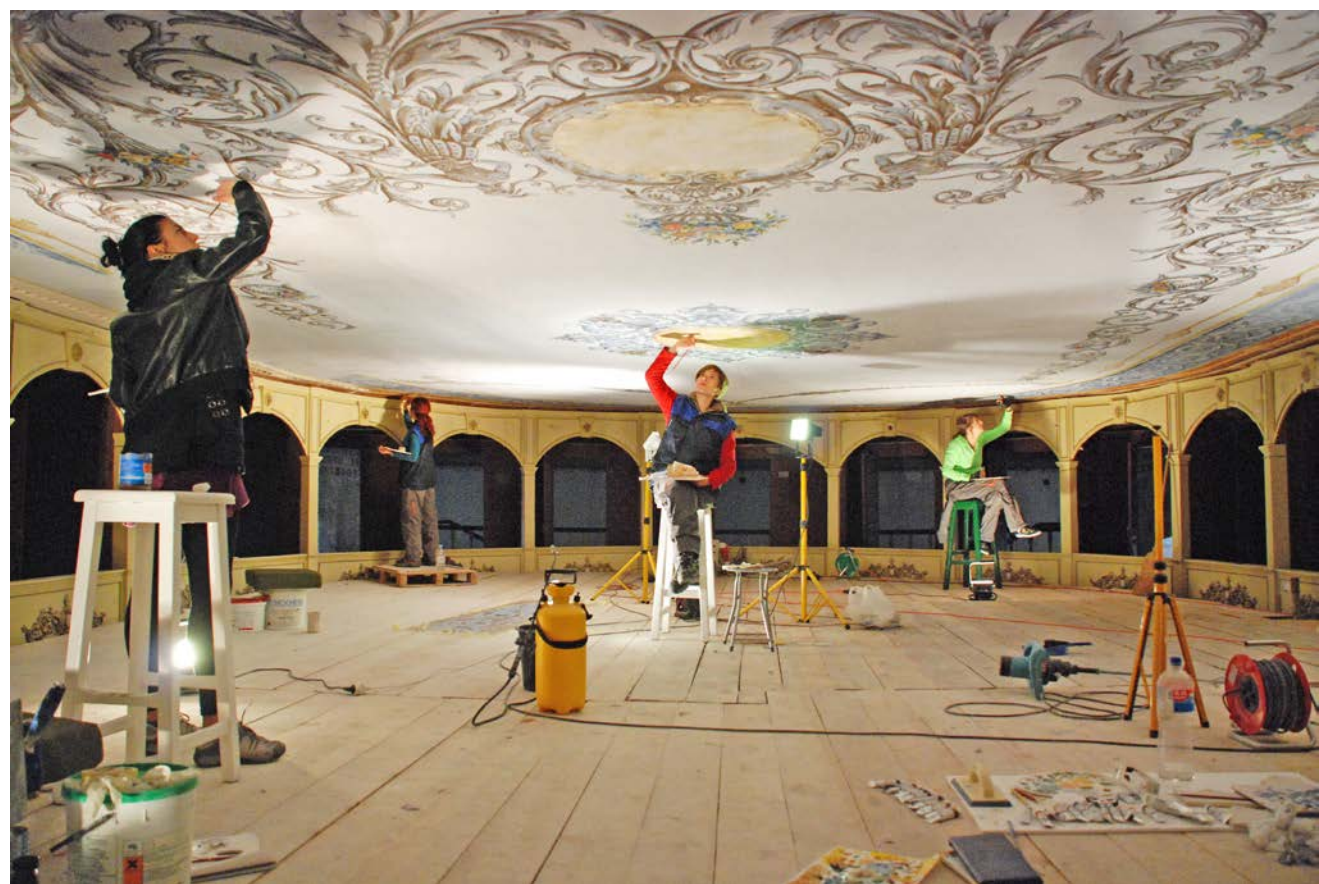
The protective techniques applied on the ceiling painting were very similar, and in some segments even identical, but – obviously – the different base structure was taken into consideration. In contrast to the wall painting, the ceiling painting covers around 70 square metres, and it hangs on the bearing wooden beam construction, the distance between the beams being bridged by a mesh of wooden lattices (*stucchette*) which served as a base for the layer of plaster. The damage to the statics of the ceiling structure was directly reflected in the ceiling painting, in that some segments of the ceiling plaster had fallen off, some segments had detached and slid, and there were numerous vein-like and capillary cracks in the plaster structure. The cause-and-effect link resulted in the painted layer being in part destroyed, and in part damaged to a greater or lesser degree with visible pulverisation zones, especially in those segments that had been exposed in the past to subsequent interventions on the painted layer. The preventive consolidation of all damaged sections consisted of either fitting protective edging, or anchoring them with wooden wedges. The plaster and the painted layer were impregnated and thus preconsolidated, and after that the surfaces of the

ceiling paintings were cleaned with a combination of mechanical and chemical methods. The figurative motif of the cardboard painted in watercolours, which was incorporated in the decorative wall frame, received a special treatment.

After the completion of the protective cleaning of the painted layers, a preventive consolidating protective coating was applied, which restored the original intensity of the pigments and the visibility of the decorative motifs of the paintings. This was followed by the development of graphic documentation, which served as a basis for recording and elaborating all subsequent restoration-documentation entries.

In the final part of the first phase of this complex conservation and restoration endeavour, a protective reinforcement layer was placed over all the painted surfaces to protect them and safeguard them from possible subsequent damage caused by the parallel protective interventions aimed at rehabilitation of the bearing beam structure. Once the face of the painting was protected, conservation and restoration treatment procedures were also applied to the back of the ceiling painting. When the layer of dust and dirt was removed, traces of paint were revealed on the reinforcing wooden lattices: we assume that these belonged to some older painted elements of the theatrical stage design, and they were reused as ordinary wooden construction material during reconstructions of the theatre interior. Both the wooden structure and the back of the plaster were impregnated and treated with biocide protection substance.
